PERFORMANCE EVALUATION OF EXISTING BUILDINGS IN THE AUGUST 24, 2016 CENTRAL ITALY EARTHQUAKE

MARIA HELENA PAIXÃO COSTA

Dissertação submetida para satisfação parcial dos requisitos do grau de
MESTRE EM ENGENHARIA CIVIL — ESPECIALIZAÇÃO EM ESTRUTURAS

JUNHO DE 2017

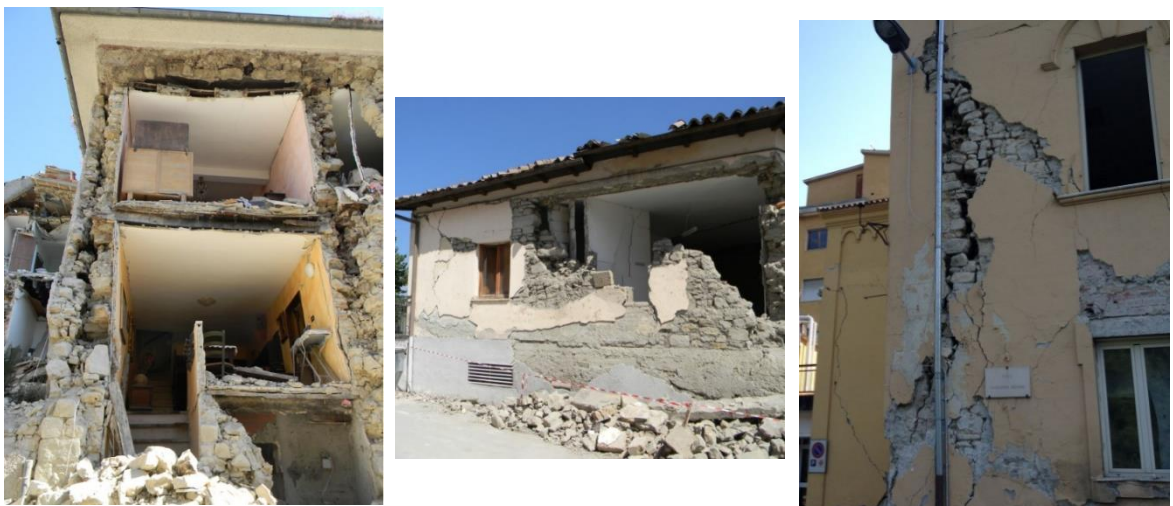
Figure 3.28 -Accumoli From left to right: vertical overturning, partial overturning and vertical cracks along the intersection between orthogonal walls

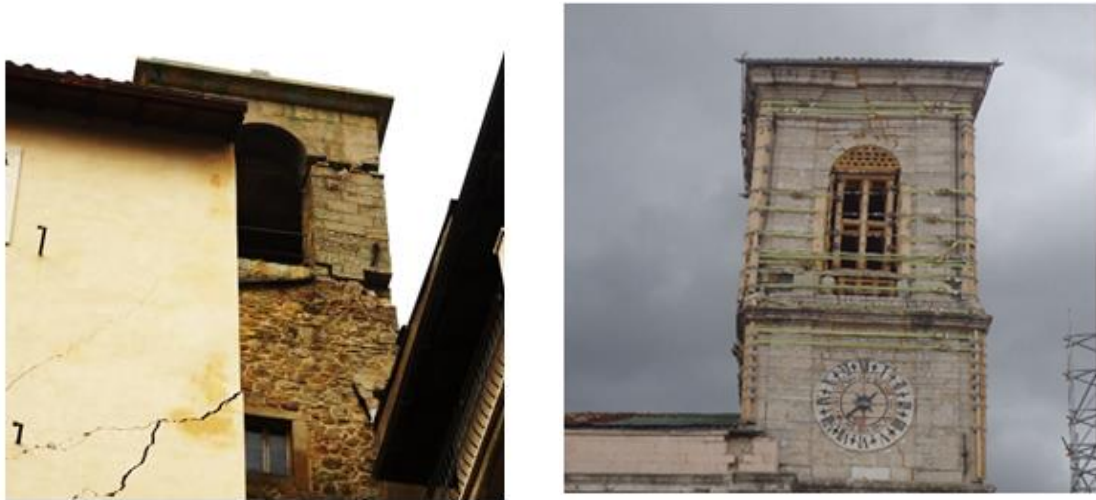
Figure 3.44-From left to right: Arquata del Tronto and Norcia

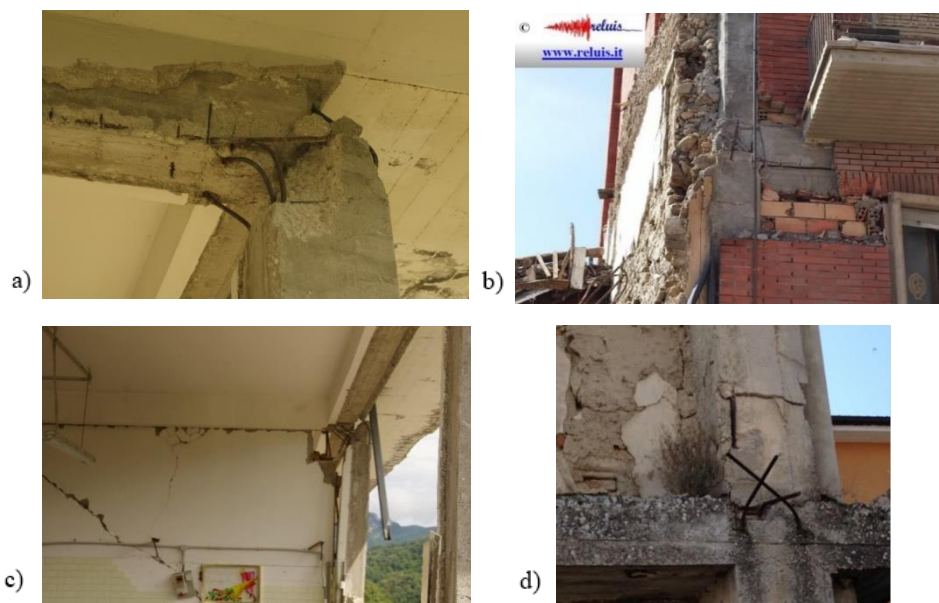
Figure 3.54-Damage in reinforced concrete beam column joint due to lack transverse reinforcement in a), b) and c). a): absence of stirrups/hoops in the beam column joint and evident poor quality of the concrete, Pescara del Tronto. b): clear separation between column and beam in the joint due to absence of reinforcement in the joint, Amatrice. c): absence of stirrups in the beam column joint, Pescara del Tronto. d): lack of stirrups in the column, Amatrice

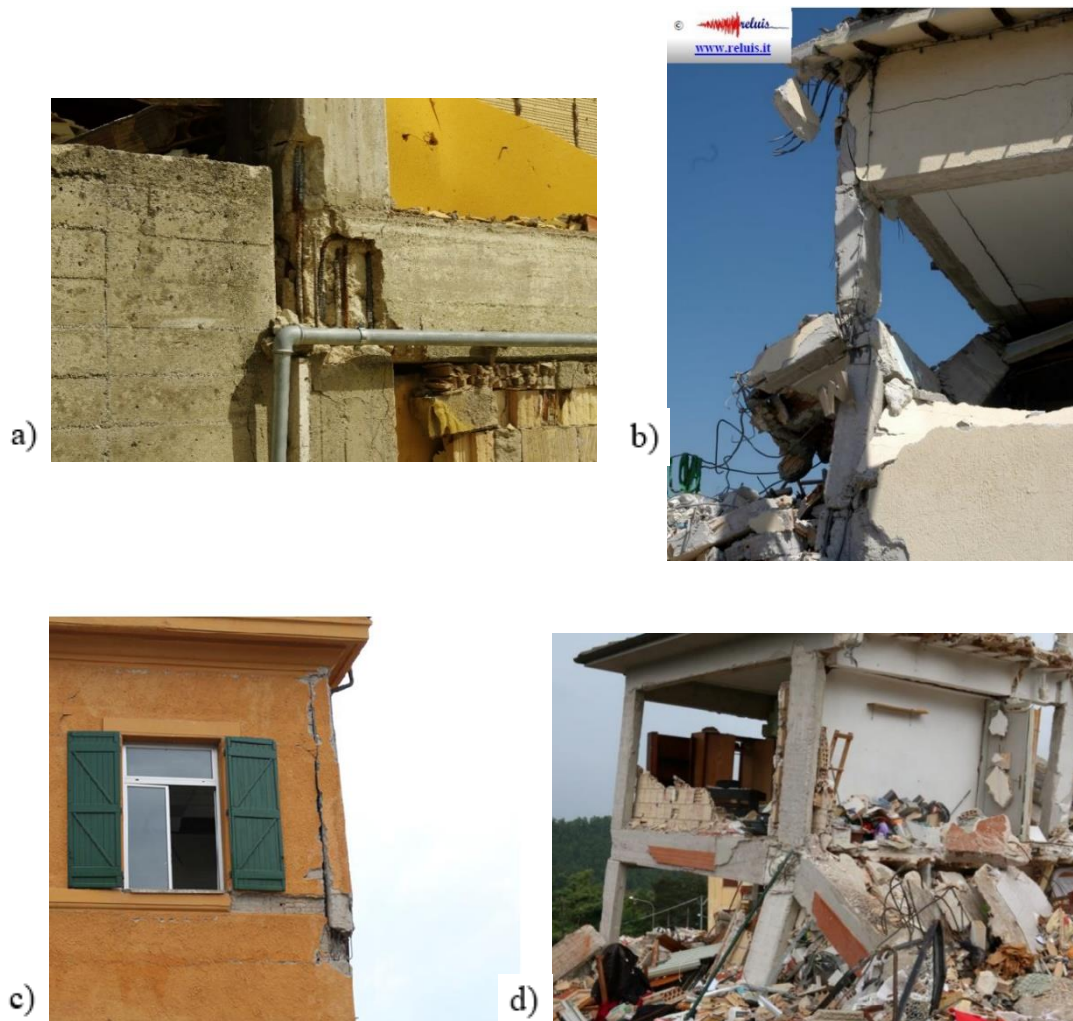
Figure 3.60-Inadequate joint behaviour in residential buildings. a) damage in the beam column joint with expulsion of the concrete cover due to lack of stirrups, Pescara del Tronto. b) damage in the joint connecting two columns and one beam - *ginocchio*, Hotel Roma, Amatrice. c) crisis in the joint between the column and the ring beam at the floor level, Amatrice. d) crisis in the joint due to lack of stirrups, Amatrice

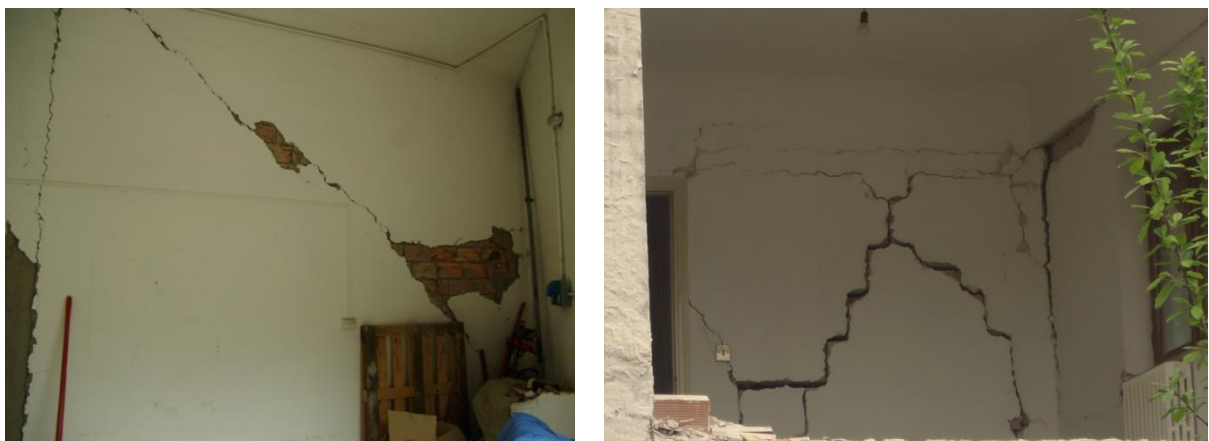
Figure 3.64-Damage in interior walls .From left to right: large diagonal crack in the infill wall with separation from the main structure. On the right, X-shaped crack forming a “stair-stepped” path due to the masonry’s weak adhesion, Norcia

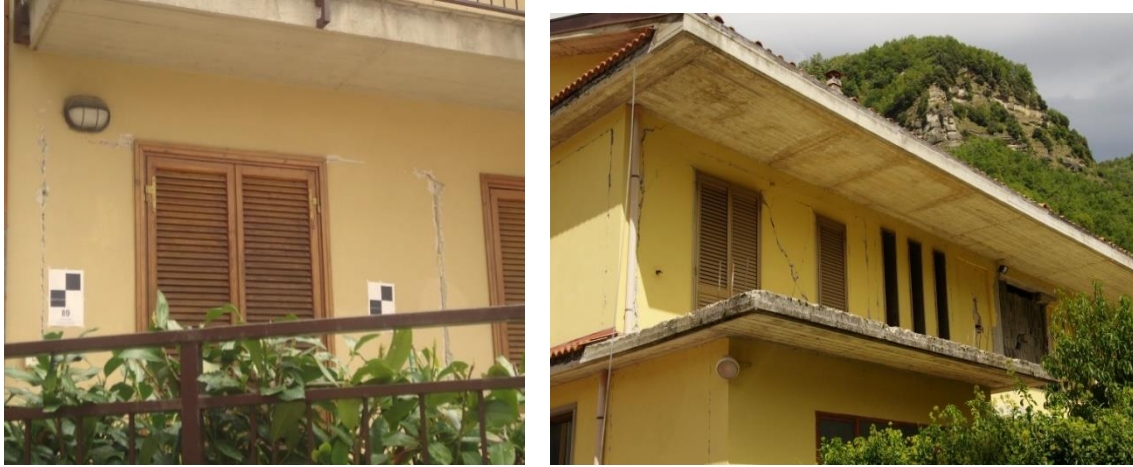
Figure 3.65- Damage in exterior walls. From left to right: clear separation between the infill walls and the structural system, Norcia. On the right, precedent case plus X-shaped cracks between two openings, Arquata del Tronto

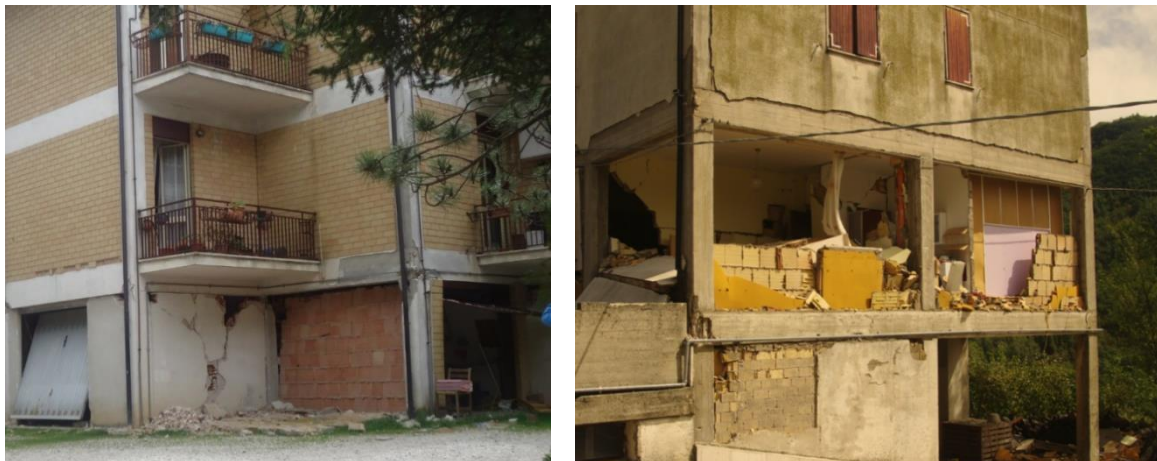
Figure 3.66 -From left to right: collapse of infills and collapse of external infill, Norcia. On the right, out of plane mechanism of the infill walls, Pescara del Tronto

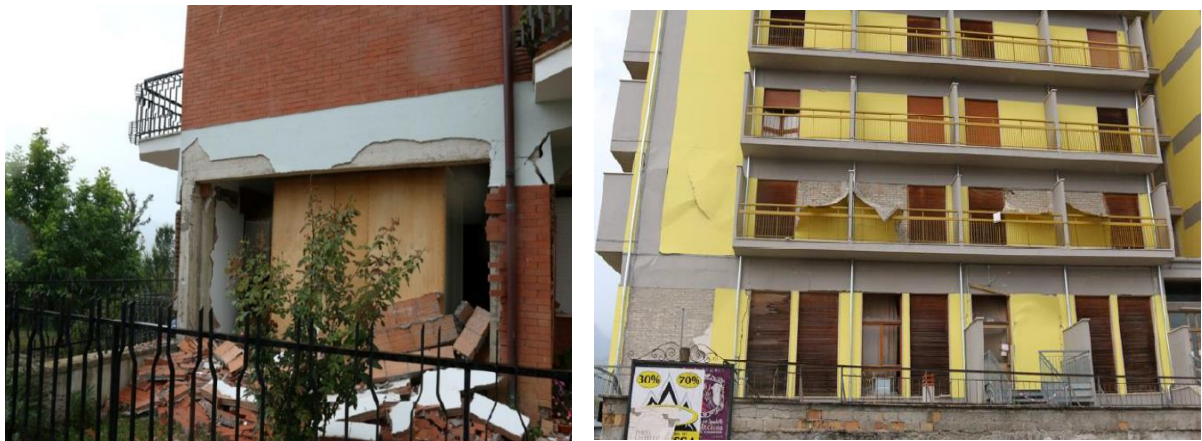
Figure 3.67 -From left to right: Out of plane failure of infills walls, Amatrice. On the right, out of plane of the coatings, Amatrice

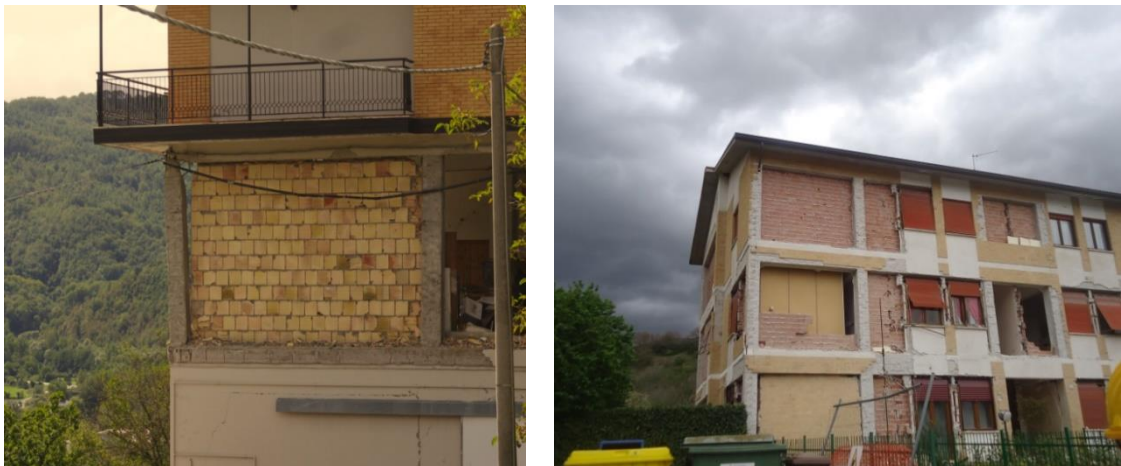
Figure 3.68- From left to right: external leaf overturning and total overturning of the infill wall (on the right), Pescara del Tronto. On the right, external leaf overturning, total/partial overturning of the infill wall and coating's overturning . This building belongs to the seventies, time of fast and poor construction, explaining the level of damage. Other buildings in Norcia's periphery present this kind of damage

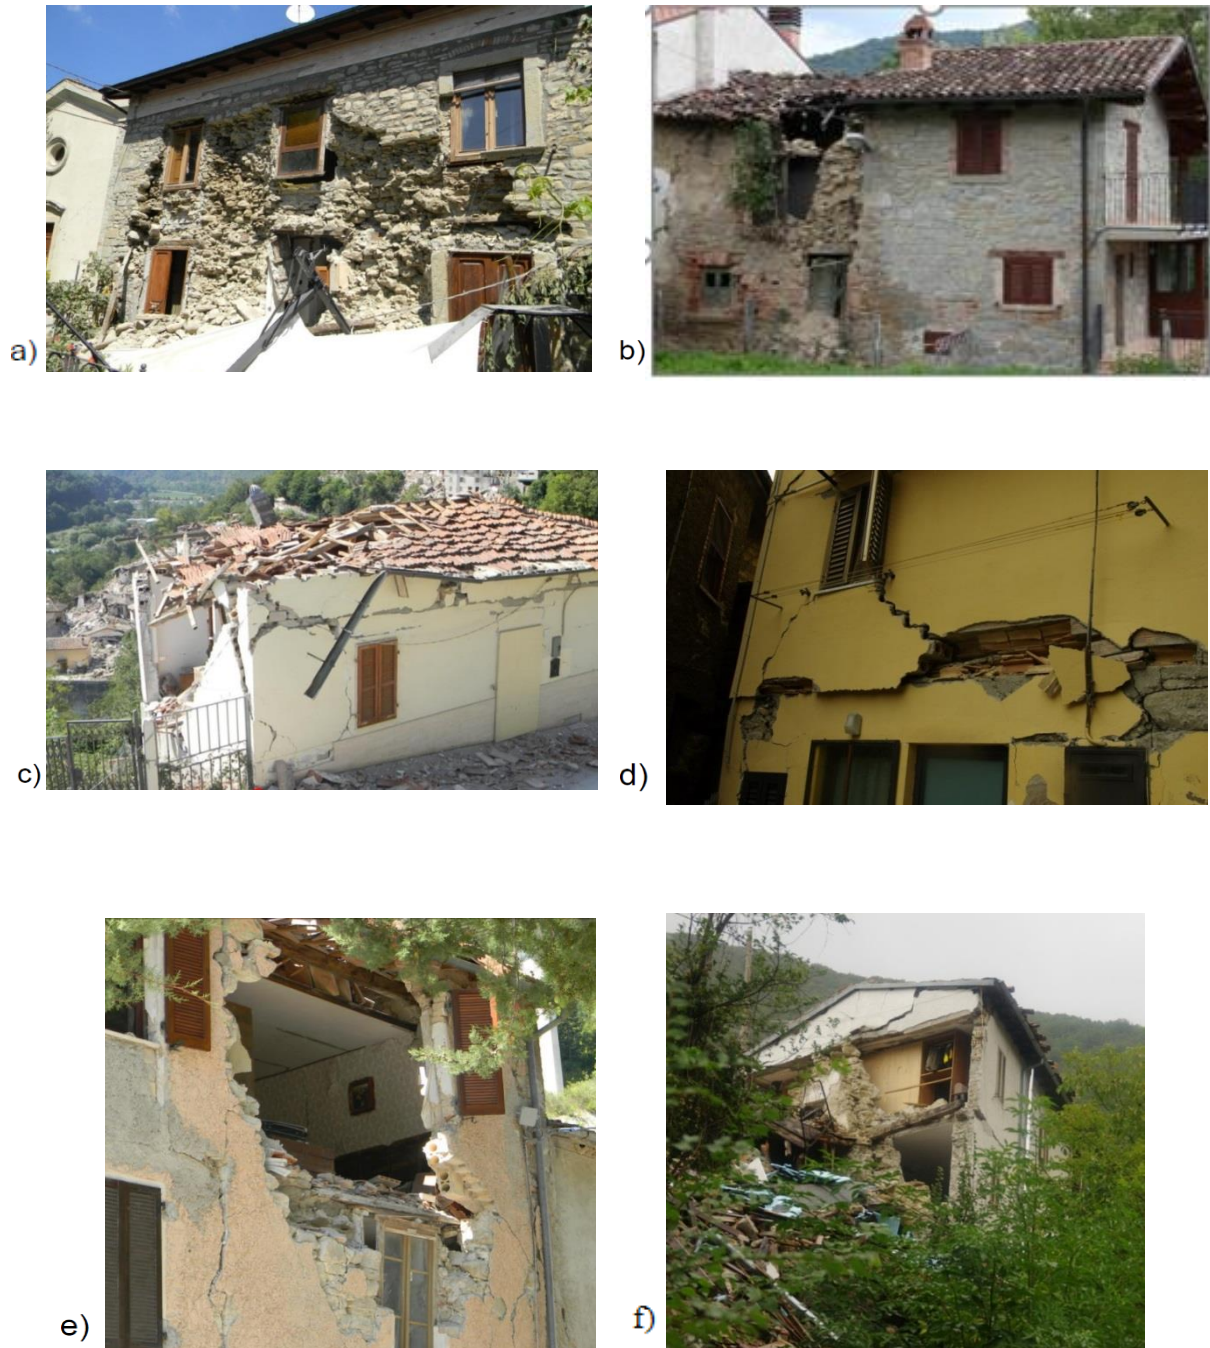
Figure 5.2-Visible poor quality of the masonry in a), b), c) and d). Pictures e) and f) besides the poor quality of the masonry presents heterogeneities in the masonry

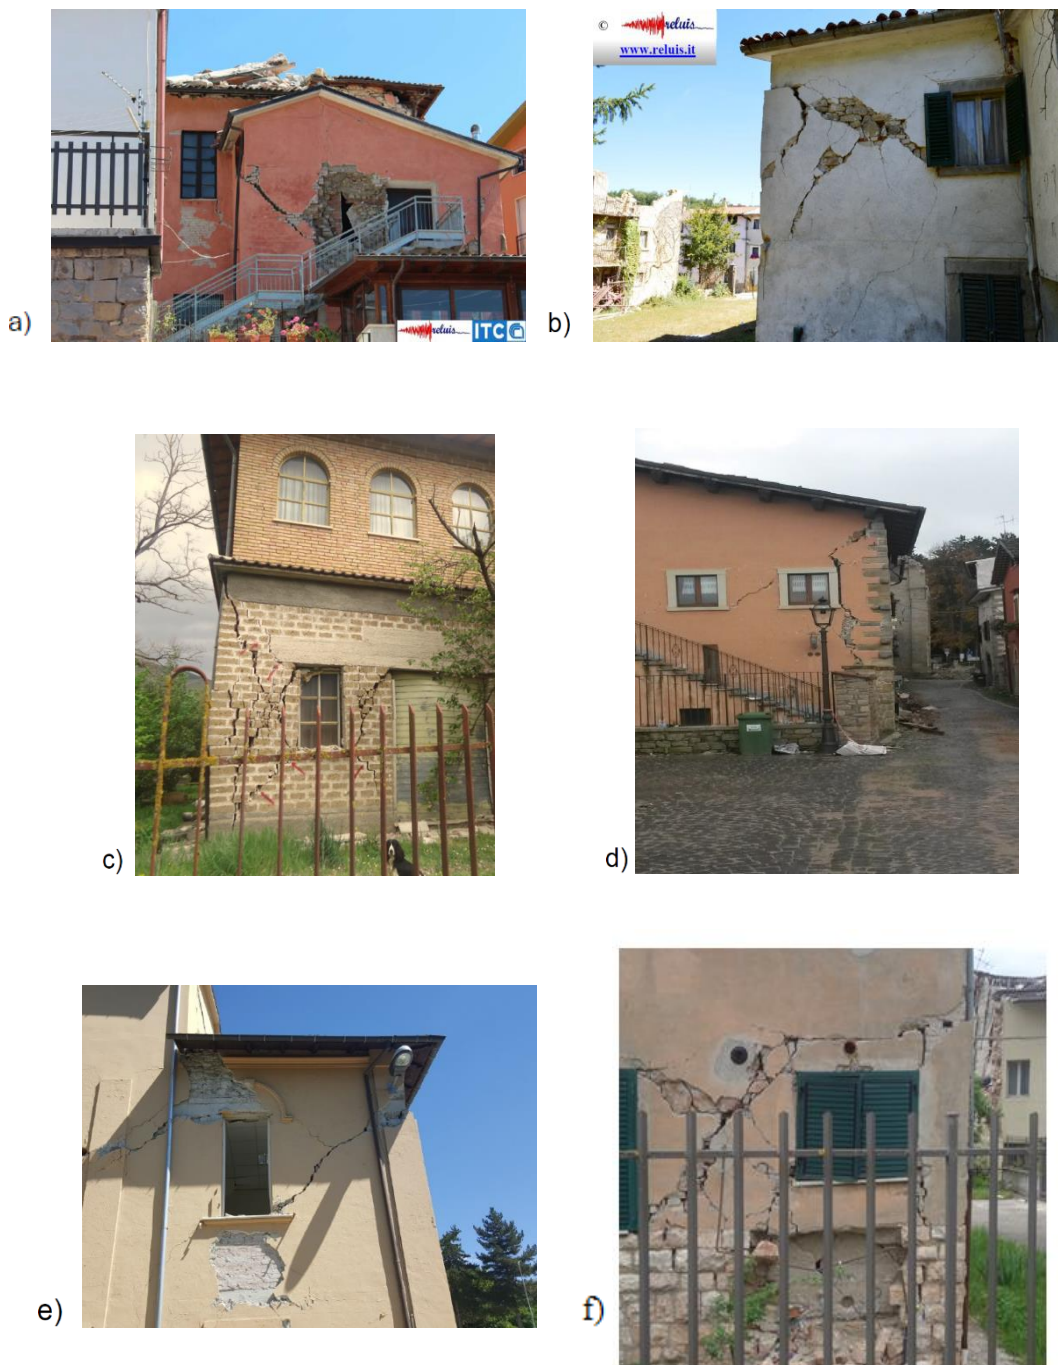
Figure 5.12 -Corner failures due to lack of confinement in pictures a), b), c), d) and e).
Picture f) is the result of an opening too close to the corner

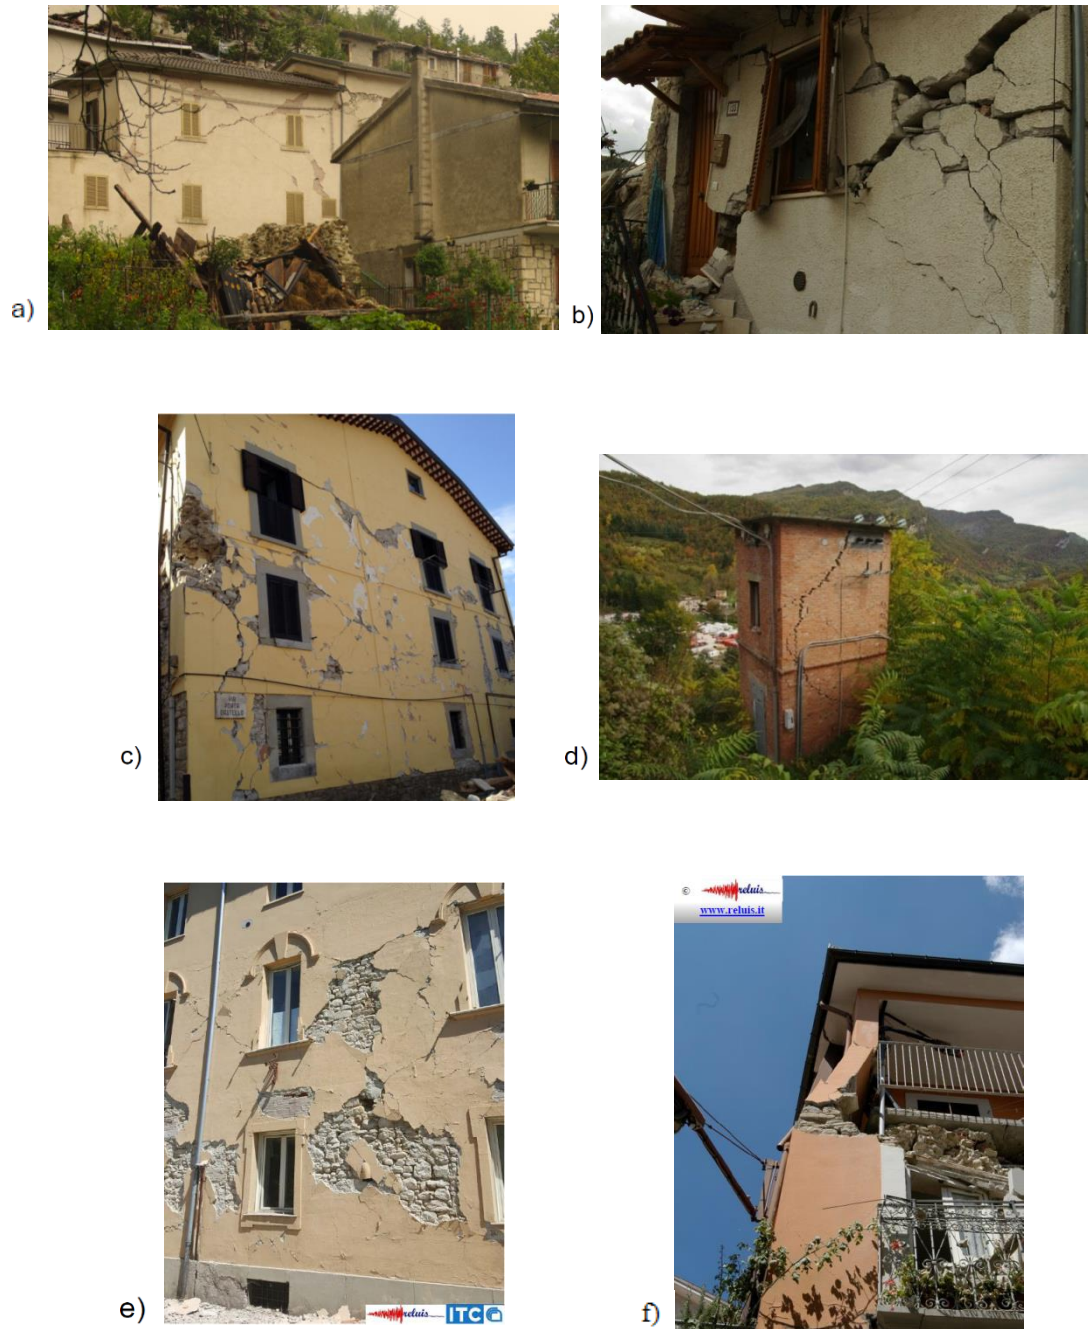
Figure 5.14 -In plane shear failure in both pier and spandrel panels and f) translation of the roof causing the rotation of the pier

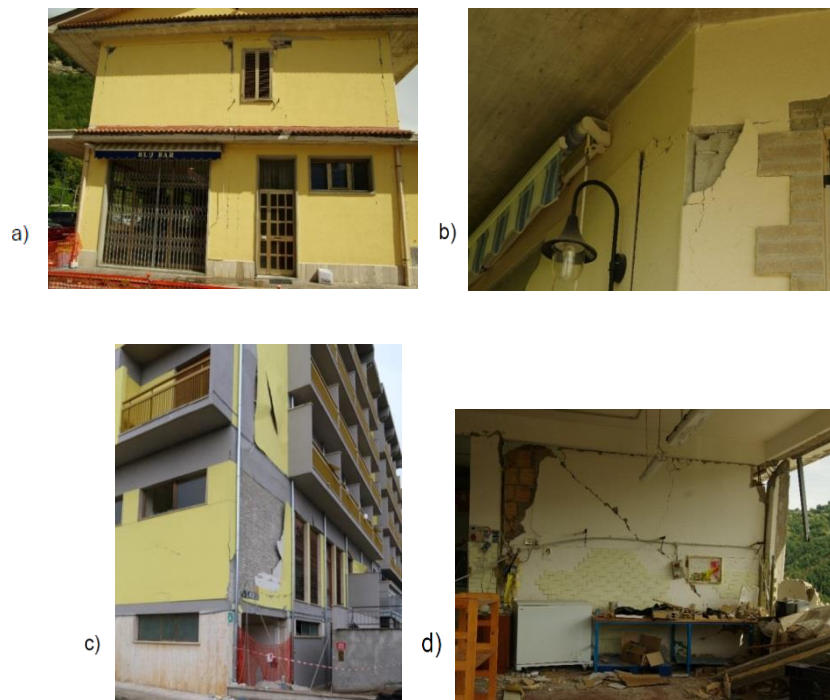
Figure 5.16 -In plane failures of masonry infills of reinforced concrete buildings in Pescara del Tronto and Amatrice

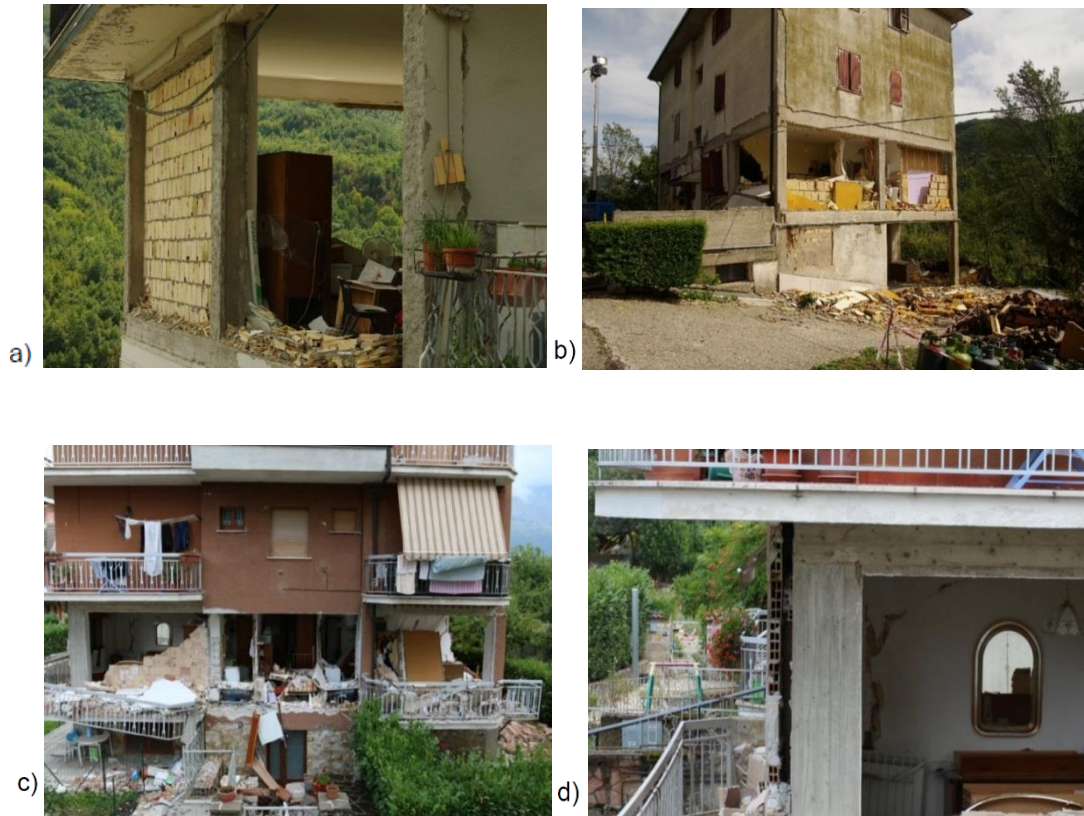
Figure 5.17 -Out of plane of infills walls in Pescara del Tronto and Amatrice

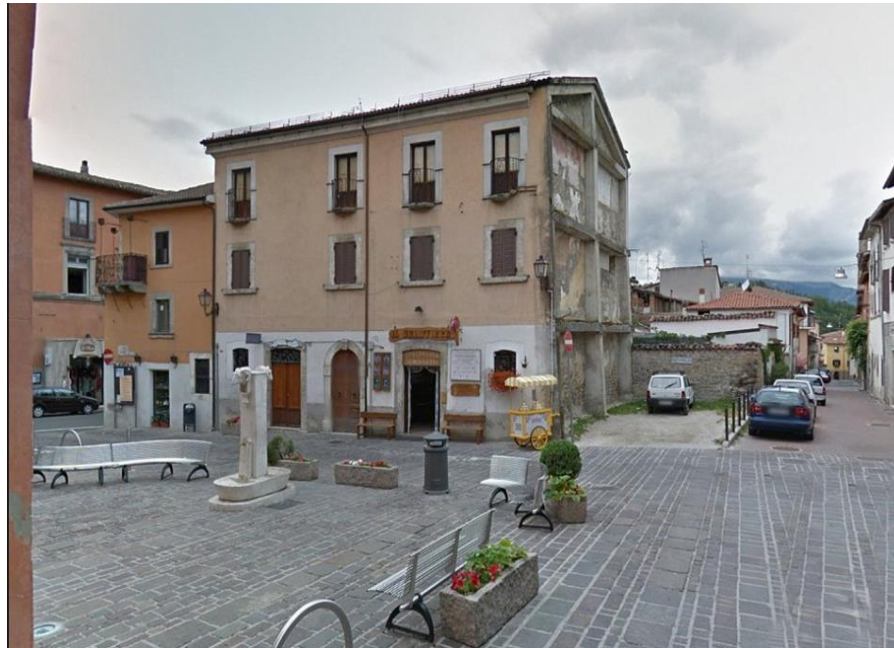
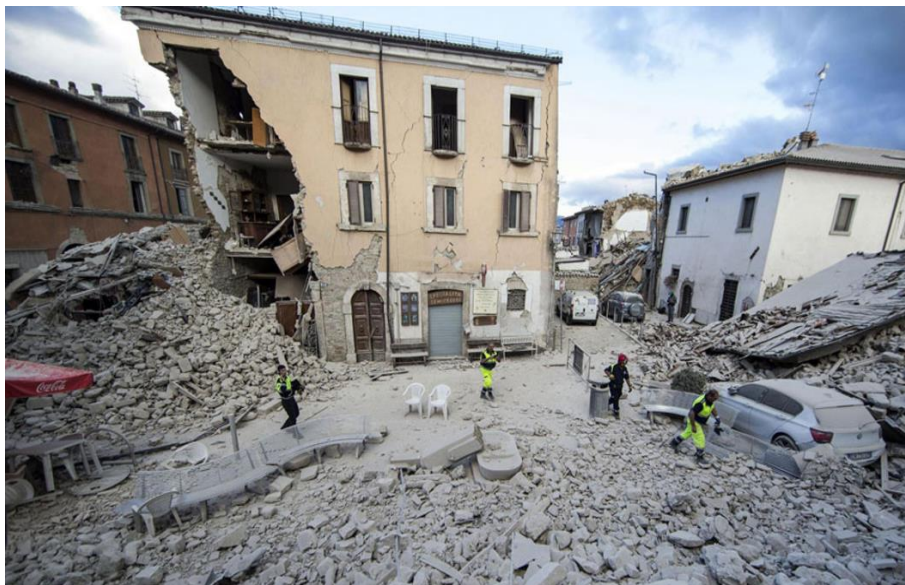
d)

Full collapse of the adjacent building on the right and partial collapse of the other on the left. The part of the building which remained standing exhibits in plane failure in the pier panels and a vertical crack along the intersection between orthogonal walls (type 3 and type 7 from AeDES classification).

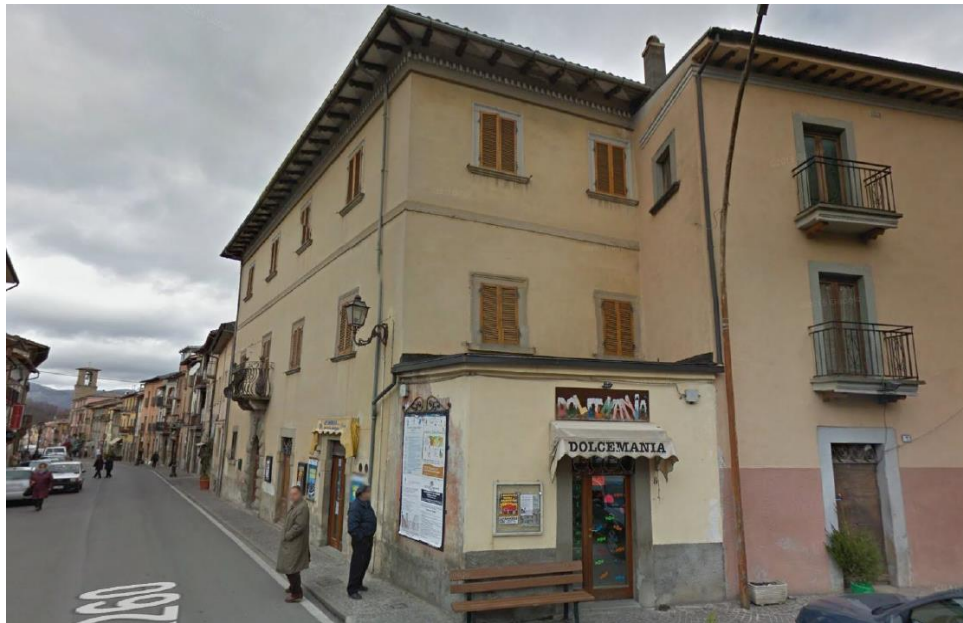
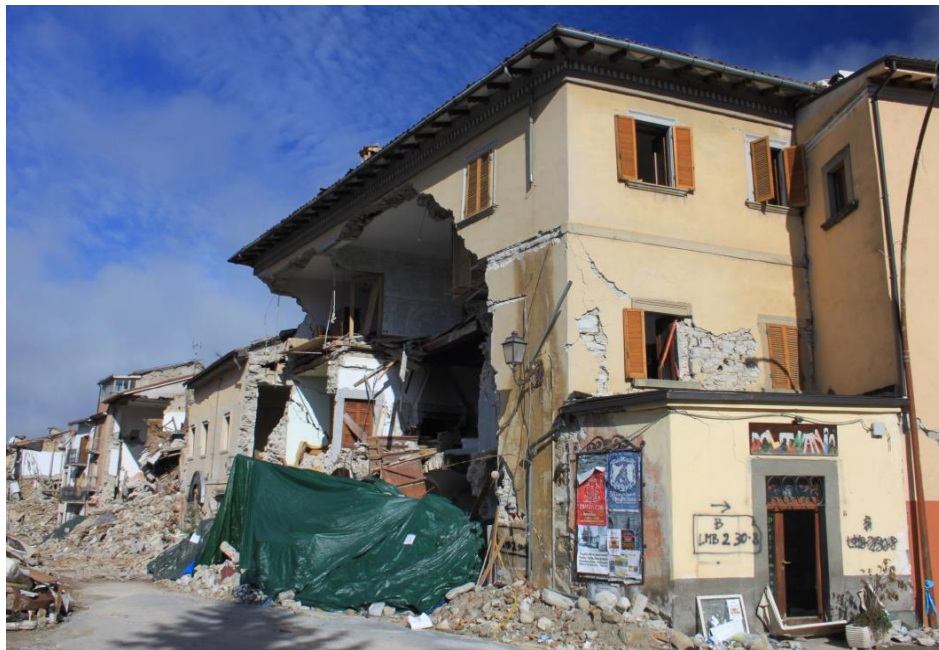
e)

Full collapse of the front façade and interaction between reinforced concrete ring beam and poor quality of the masonry.

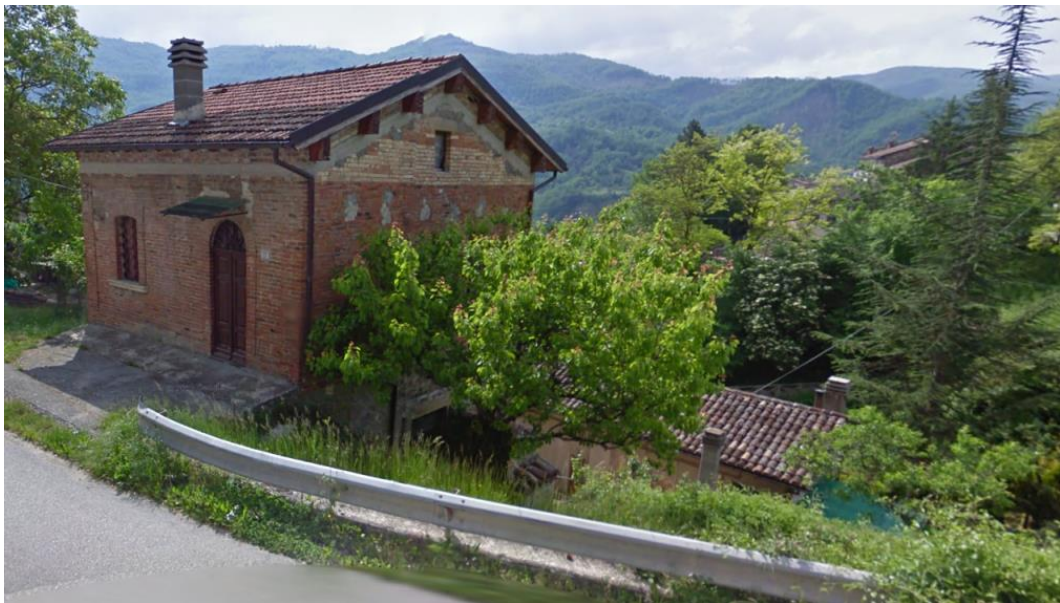
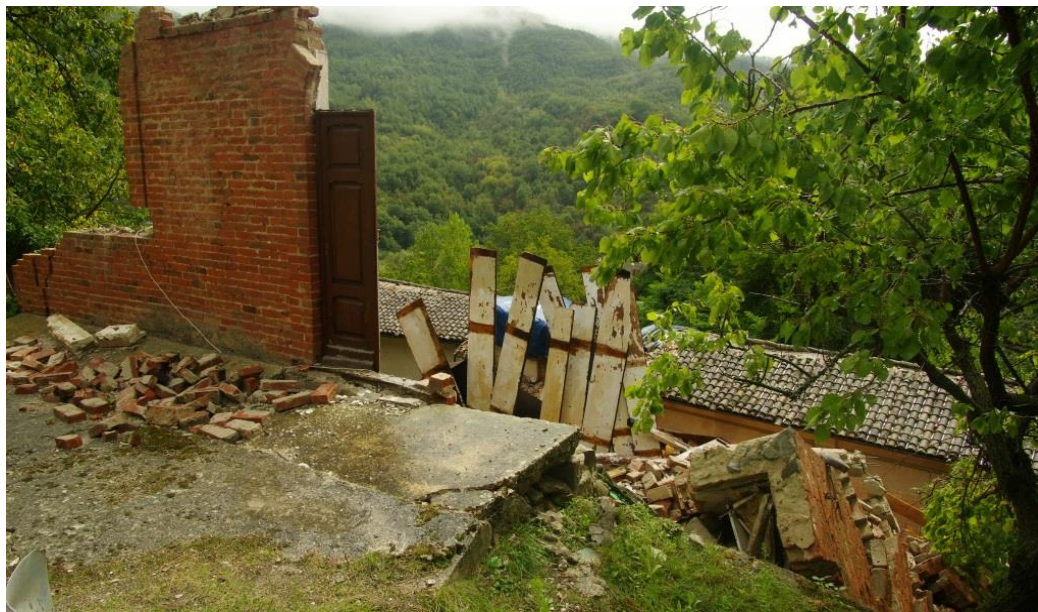
c)

Global collapse of a brick masonry structure. This is one of the many cases where the terrain conditions are very hostile due to its steep slope.

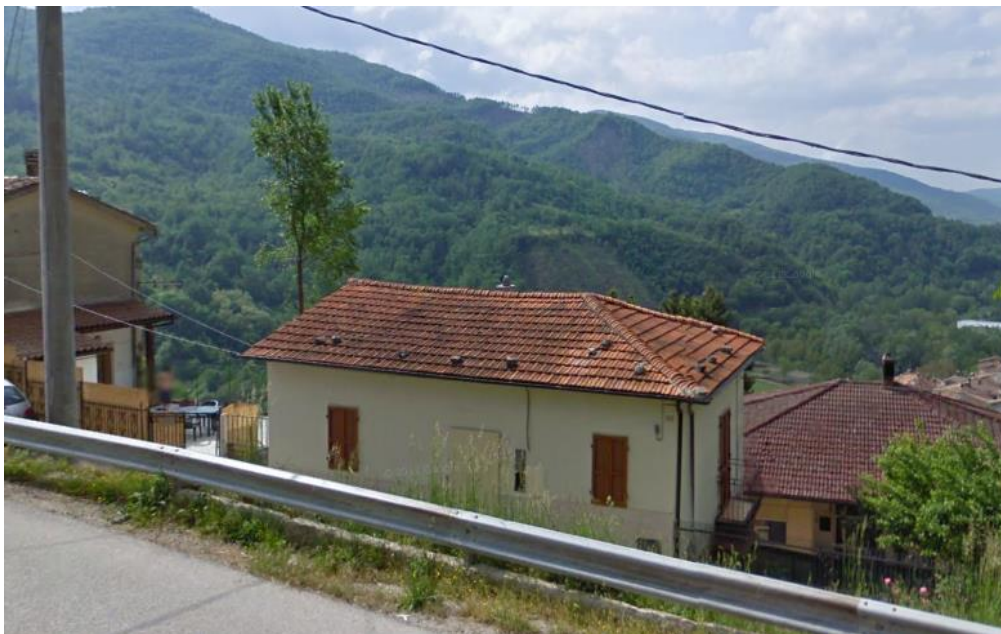
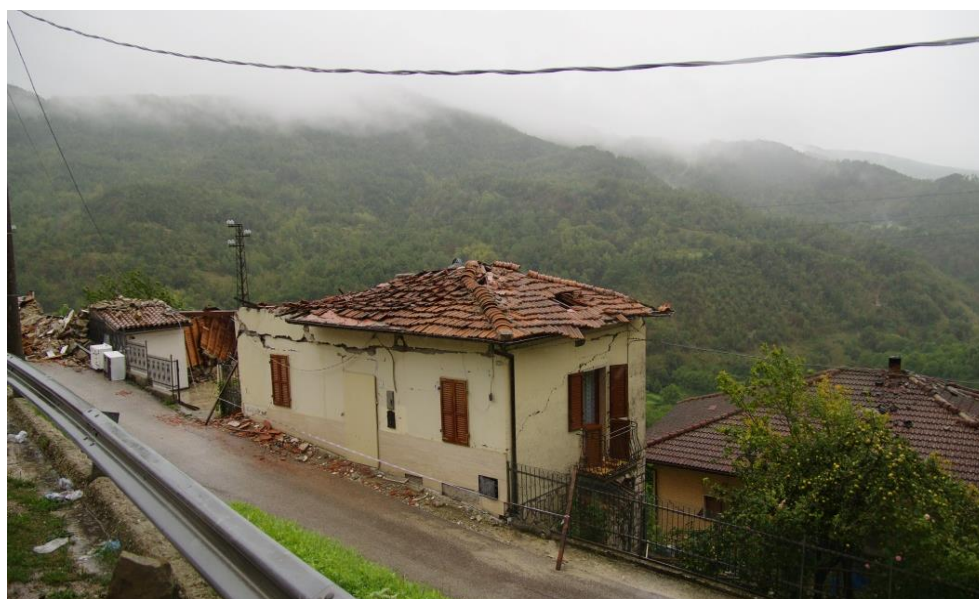
e)

Partial collapse of one masonry building in a steep terrain. In section 5.1.1 is visible the wrong type of masonry used in this structure leading to its failure.

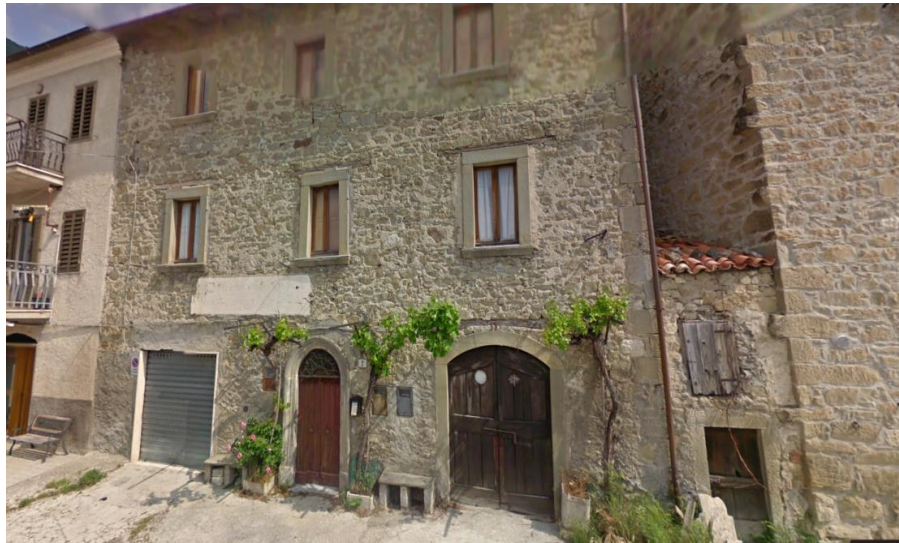
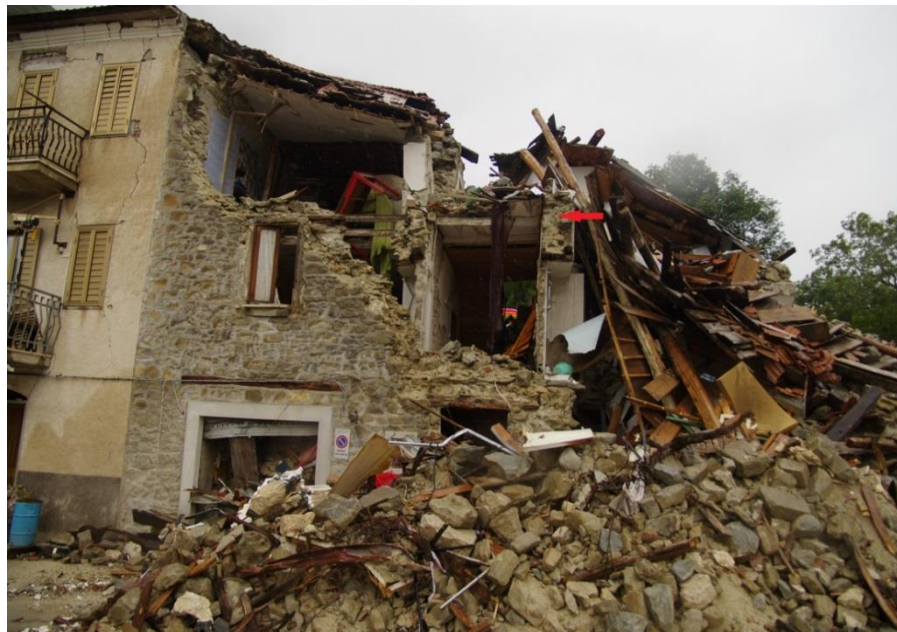
Evident different behaviour between two adjacent buildings: global collapse of masonry buildings on the right and standing building on the left, only displaying in plane cracks. Collapsed building presents absent connection between diaphragm and vertical elements, visible on the right side (red arrow). Regarding the in plane cracks in the left structure, there is a mixture of shear and flexure cracking: windows corners exhibit flexural cracks of both pier and spandrel panels (type 1 and 5 from AeDES classification) and also diagonal shear cracking in both pier and spandrel panels (type 2 and 3 from AeDES classification).

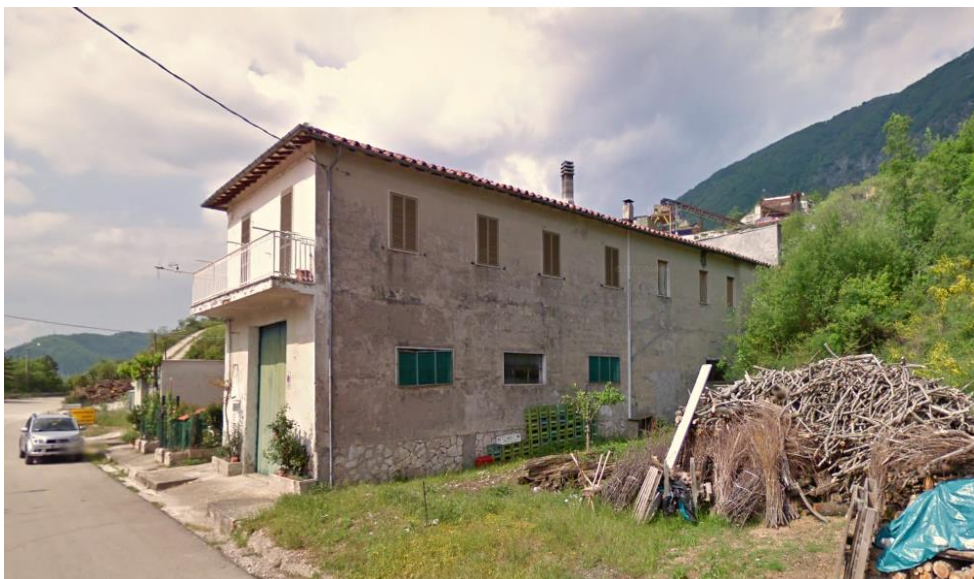
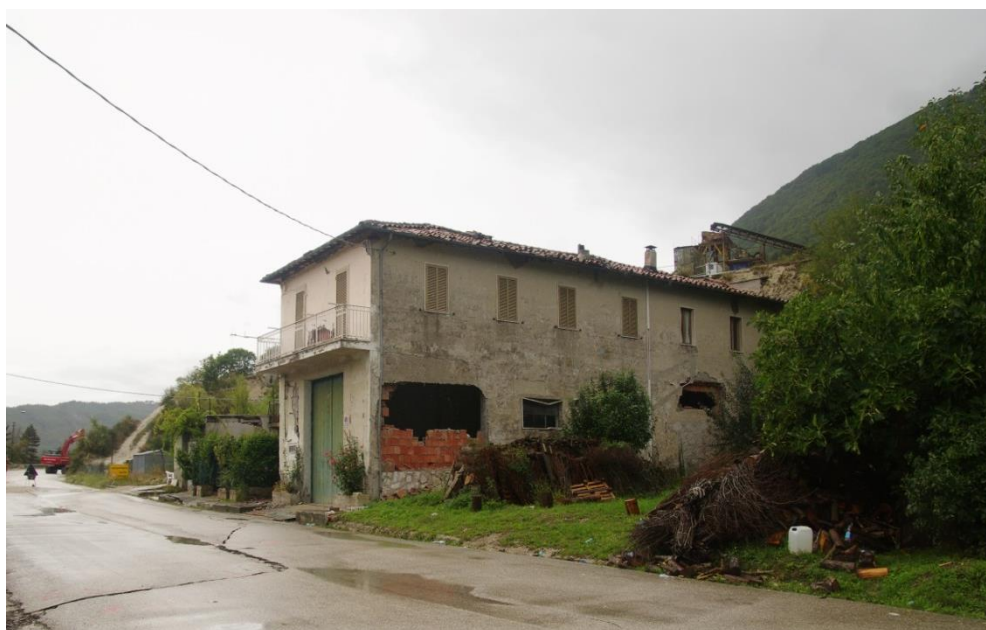
Out of plane behaviour of the brick (*mattoni semipieni*) panels, uncovering old openings that have been closed. Probably the defective connection between the bricks and the steel lintels activated the mechanism.

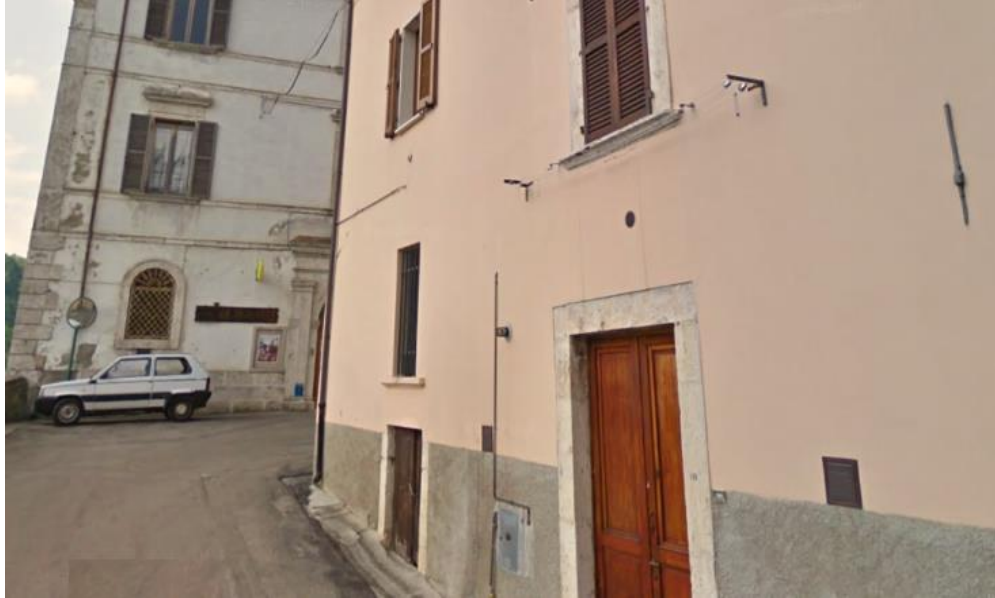
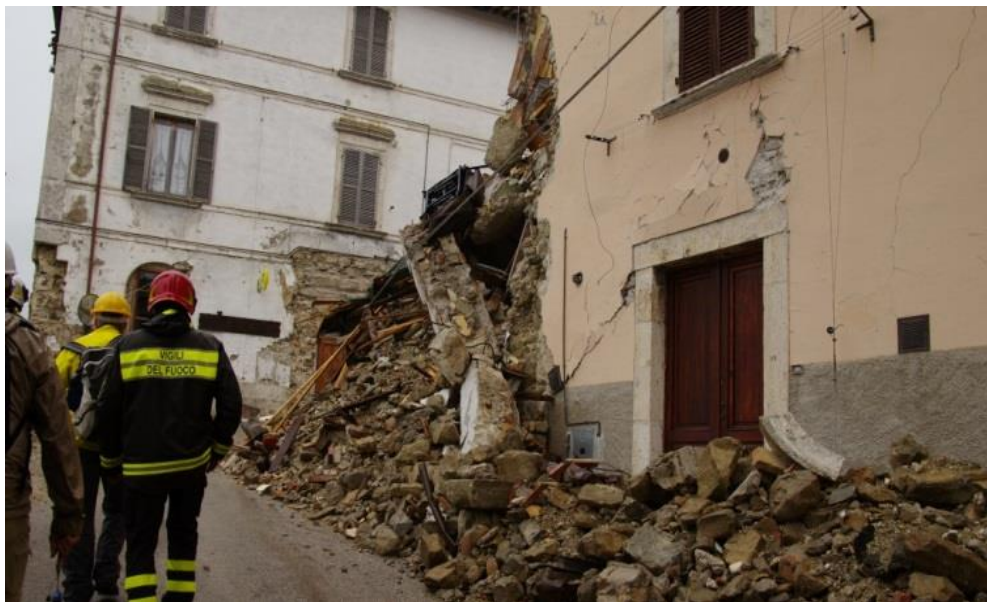
Partial collapse of a masonry building. Visible poor quality of the masonry and in plane shear cracking in both pier and spandrel panels (type 2 and 3 from AeDES classification) with detachment of material in the spandrel panel.

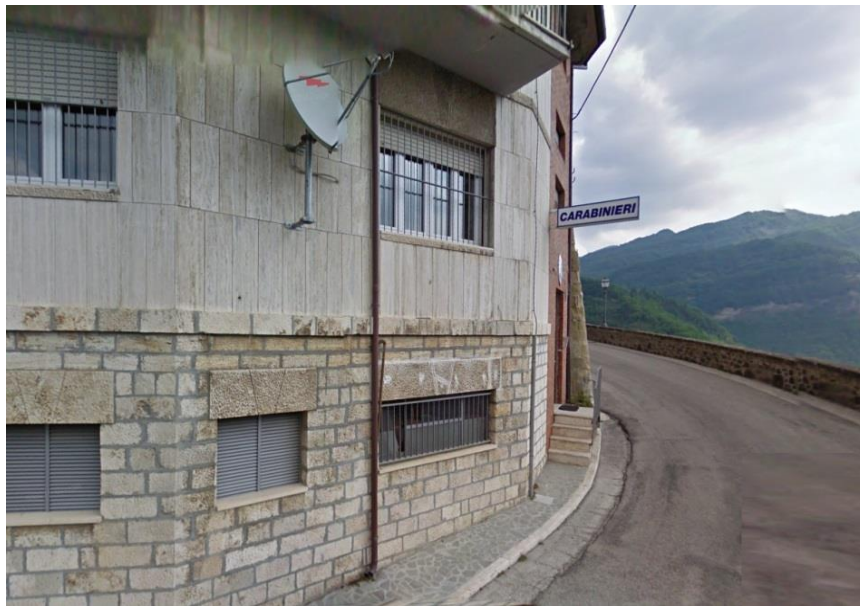
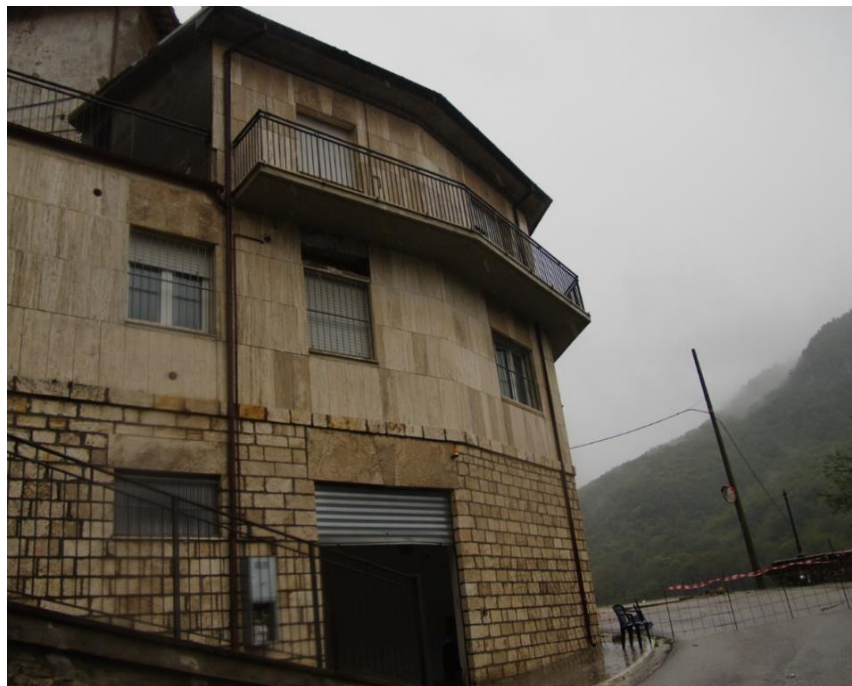
Landslide due to failure of a retaining wall, more detailed in section 4.1.2.1.
